# Manhole Inspection Summary

Manhole # S23MM\_032MH

**Location** Address: **2624 Francis-Druid Hill Alley**

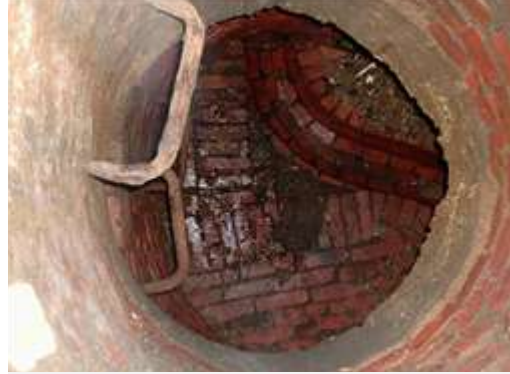
Top View

Corroded steps. Evidence of surcharge - Bench debris.

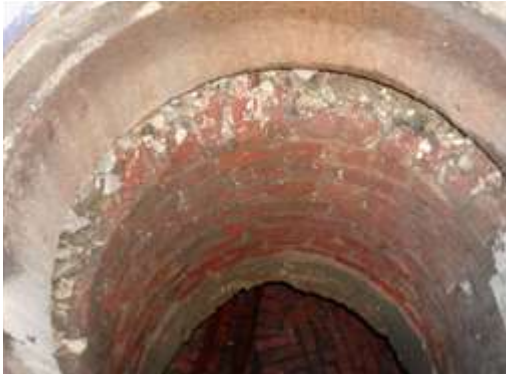
Defect

Frame leaks. Frame offset. Adjustment deterioration and infiltration - other side.

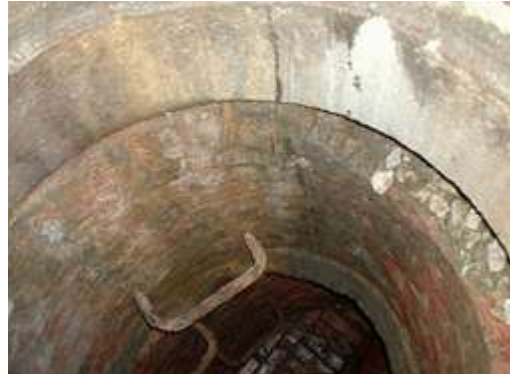
Defect

Frame leaks. Frame offset. Adjustment deterioration and infiltration. Barrel infiltration.

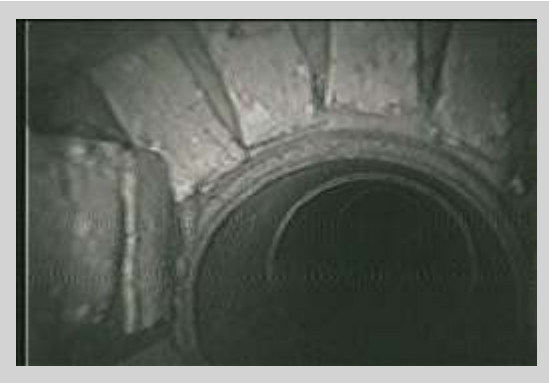
### 8 in. Circular Gravity Sewer Pipe Out @ 12 O'Clock

Infiltration: **None** Pipe Seal Cond: **Unknown**

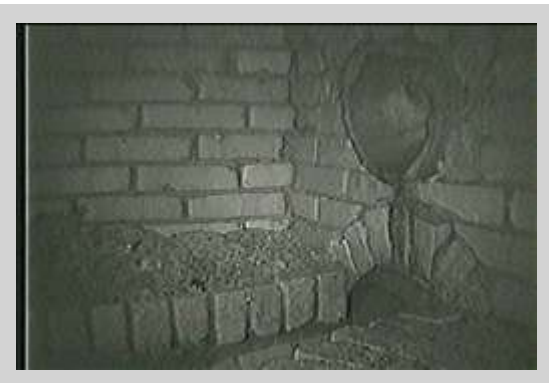
### 8 in. Circular Gravity Sewer Pipe In @ 6 O'Clock

Comments **The I3 pipe in and the I3 drop ext. are in the same pipe picture.**

Drop: **Outside** Rod and Bar

Drop Condition: **Open**
